# **Connecticut Coastal Structures Inventory Study**

PHASE I - NEW LONDON COUNTY

APPENDIX C  
NEW LONDON QUADRANGLE  
RECORDS OF STRUCTURES WITH PHOTOGRAPHS

SEPTEMBER 1988

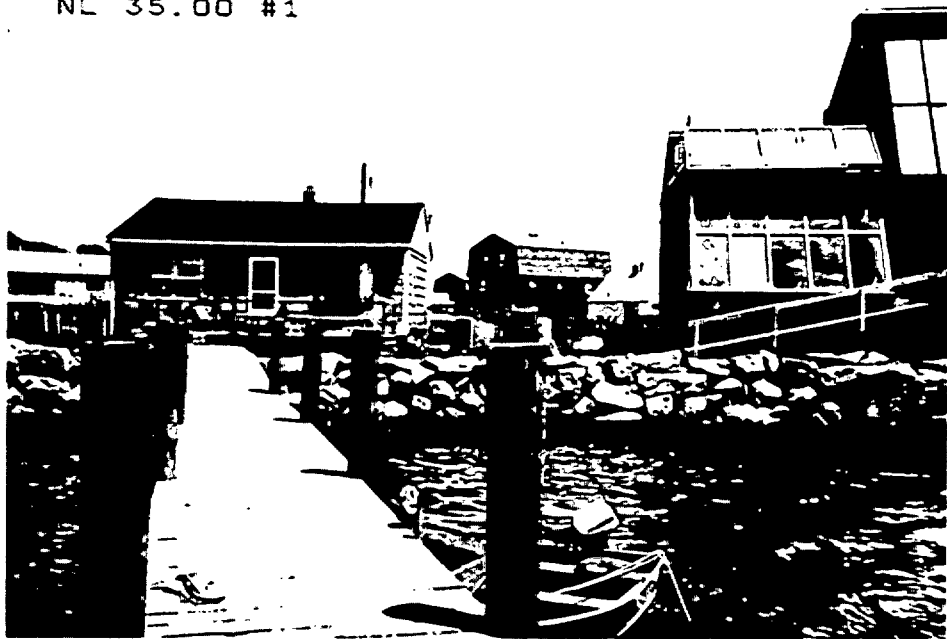
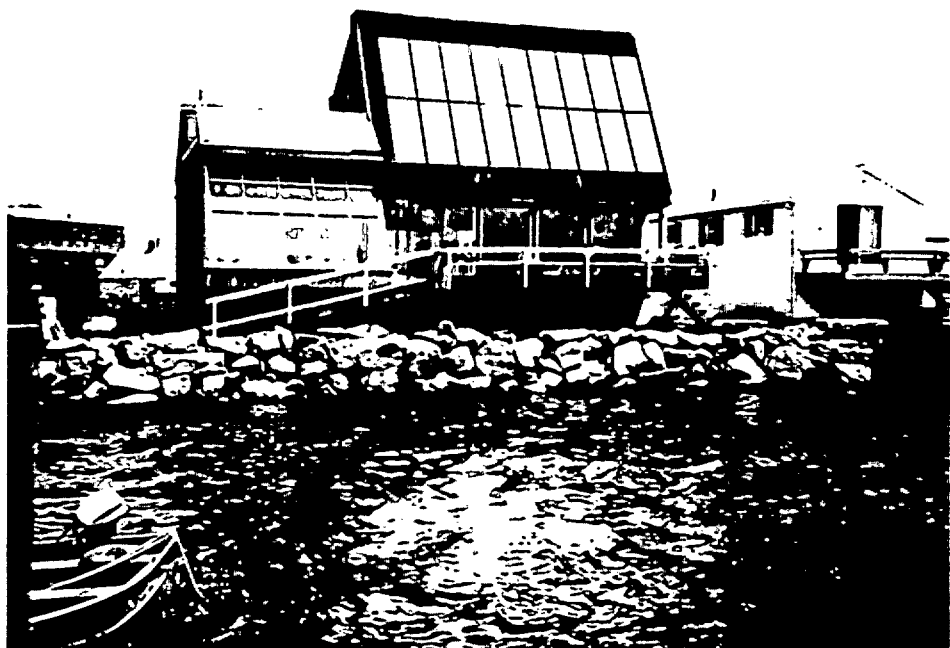
NL 35.00 #1

TYPE OF STRUCTURE: SEAWALL CONDITION: GOOD  
MAIN FUNCTION : RETAINS PRIVATE LOTS AND TWO HOMES  
MATERIAL : LARGE BOULDERS

SHORE ALMOST COMPLETELY LINED WITH PROTECTIVE STRUCTURES  
FROM TIP OF JUPITER POINT TO 35. NORTH OF 35 ARE 3 HOUSES  
WITH NO PROTECTION. JUST SANDY BEACH.

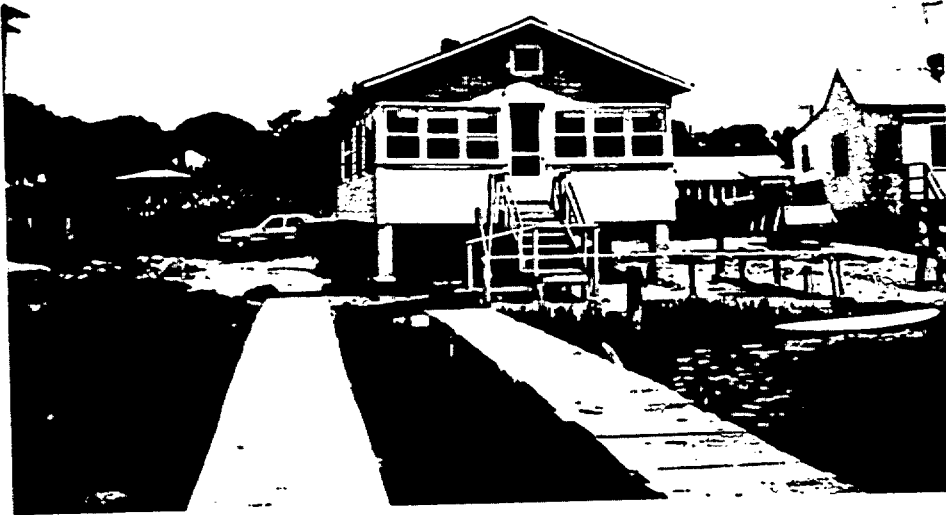
NL 36.00 #1

TYPE OF STRUCTURE: SEAWALL CONDITION: FAIR  
MAIN FUNCTION : RETAINS SAND IN FRONT OF PRIVATE HOMES  
MATERIAL : WOOD

SANDY BEACH TO EAST DEVELOPED AND PROTECTED. SHORELINE TO  
WEST IS MARINA AND PARKING LOT.

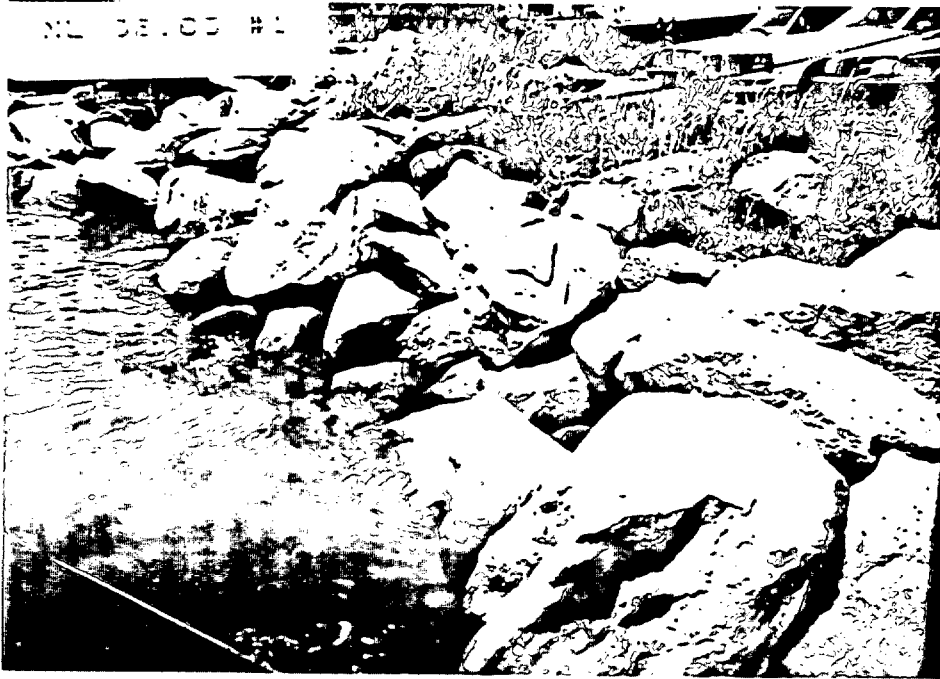
NL 38.00 #1

TYPE OF STRUCTURE: REVETMENT CONDITION: FAIR  
MAIN FUNCTION : RETARDS EROSION OF LAND ON WHICH PIERS ARE BUILT.  
MATERIAL : LARGE ROCKS

MARSHY GRASSY SHORELINE WHERE UNPROTECTED, BUT MOST OF  
SHORELINE IS LINED WITH PROTECTIVE STRUCTURES

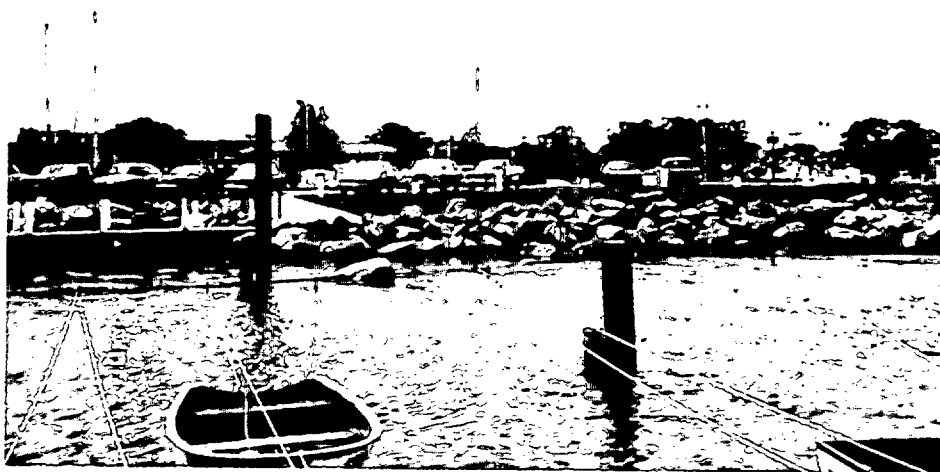
NL 39.00 42

TYPE OF STRUCTURE: REVETMENT CONDITION: GOOD  
MAIN FUNCTION : HALTS EROSION OF LAND SUPPORTING PIERS AND PARKING  
MATERIAL : LARGE STONES

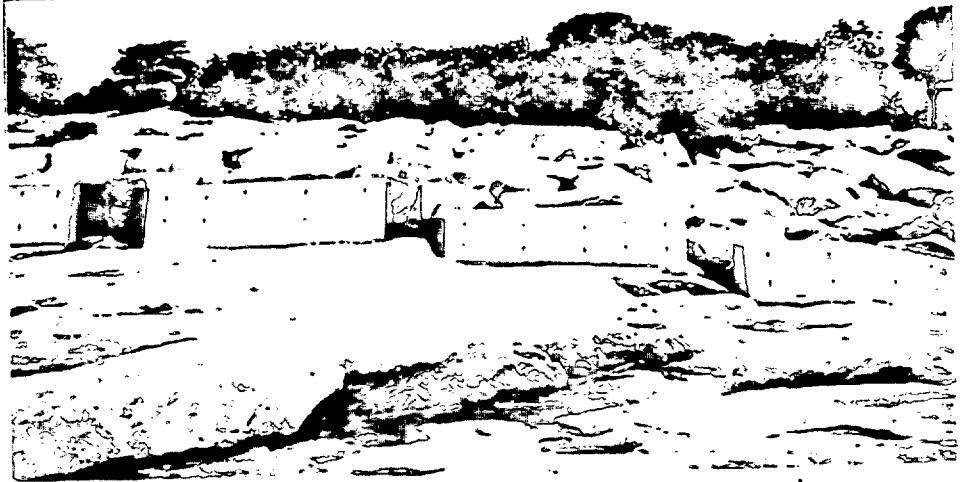
TYPE OF STRUCTURE: REVETMENT CONDITION: FAIR  
MAIN FUNCTION : PROTECTS SLOPE FROM EROSION, RETAINS LAND  
MATERIAL : STONE

TIP OF PT IS A ROCKY PROMINTORY (SOUTH SIDE) WEST SIDE OF PT  
IS PARTIALLY ARMORED WITH STONE. LAND AT TOP OF SLOPE IS  
ERODING.

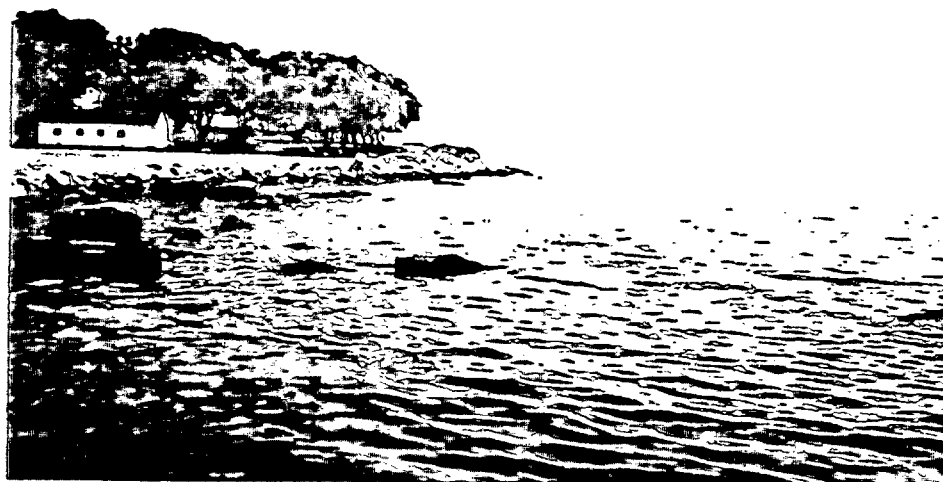
NL 42.50 #1

TYPE OF STRUCTURE: REVETMENT CONDITION: POOR  
MAIN FUNCTION : RETAIN PROPERTY  
MATERIAL : LG. ROCKS

ROCKY SHORELINE ON TIP OF AVERY PT. UPPER THIRD TO HALF OF  
REKETMENT SEEMS TO BE MISSING. SOIL IS FALLING DOWN EXPOSED  
SLOPE (SLOWLY).

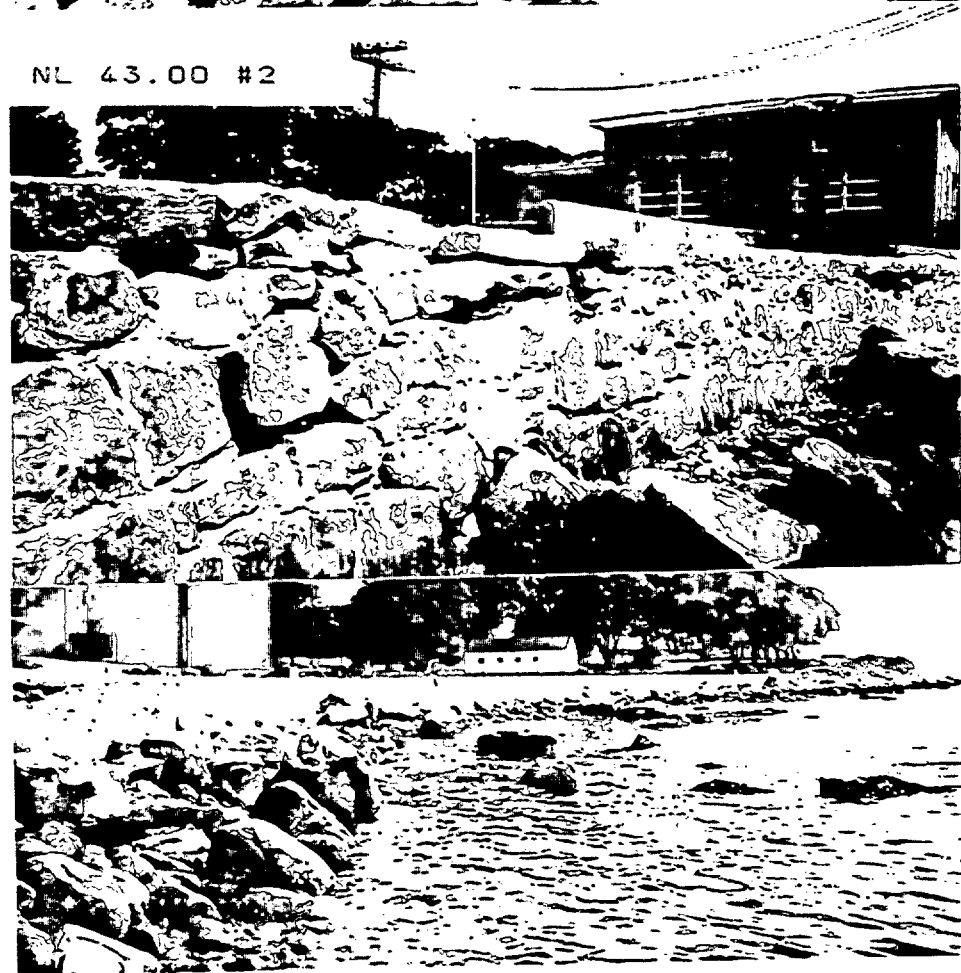
TYPE OF STRUCTURE: SEAWALL CONDITION: POOR  
MAIN FUNCTION : RETAINS PARKING LOT  
MATERIAL : STONE IN CEMENT

SEAWALL BROKEN THROUGH IN MANY PLACES.

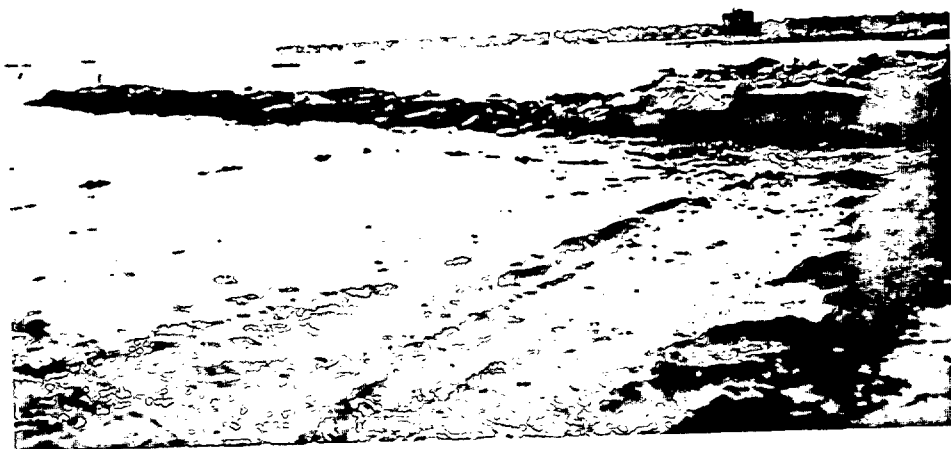
NL 44.00 #1

SANDY BEACH TO WEST OF GROIN

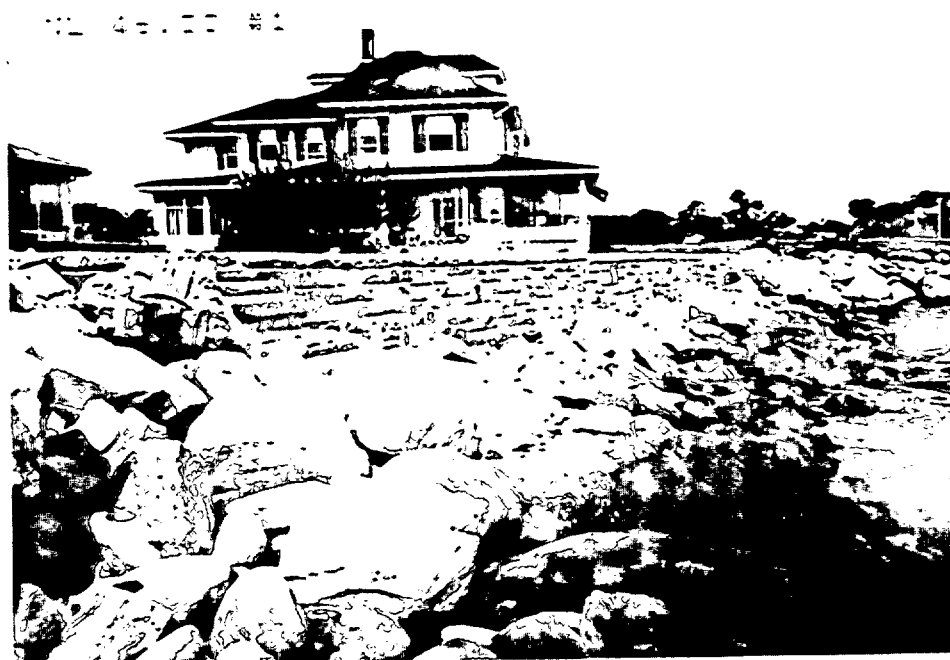
TYPE OF STRUCTURE: SEAWALL CONDITION: GOOD  
MAIN FUNCTION : RETAIN/SUPPORT LAND AND PROTECT FROM WAVE ACTION  
MATERIAL : BLOCK IN CEMENT

BOULDERS PLACED IN FRONT OF WALL.

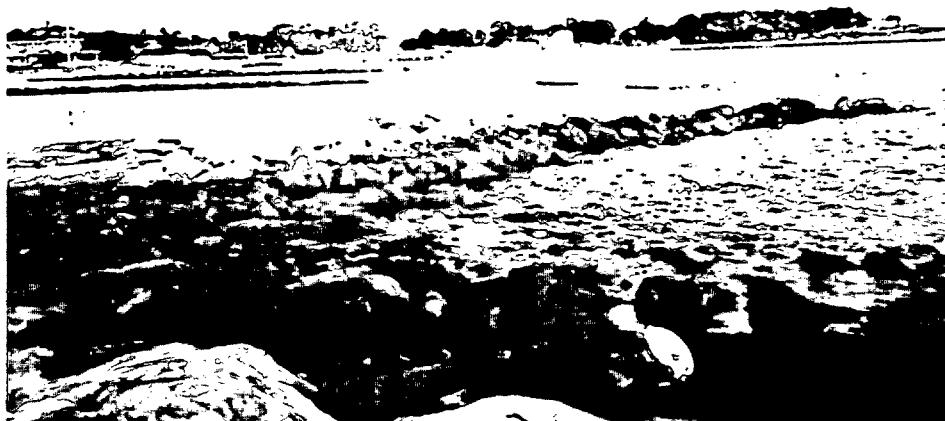
21 80.00 21

TYPE OF STRUCTURE: GROIN CONDITION: FAIR  
MAIN FUNCTION : SHELTERS/TRAPS/RETAINS SAND FOR GROTON PRIVATE BEA  
MATERIAL : LARGE ROCKS

SHORE: EXPOSED BEDROCK AT POINT, SANDY BEACH TO EAST
